EQUINE TOMOSYNTHESIS

Head (P0041, 11 Aug 2020)

Diagnosis: Multiple skull fractures.

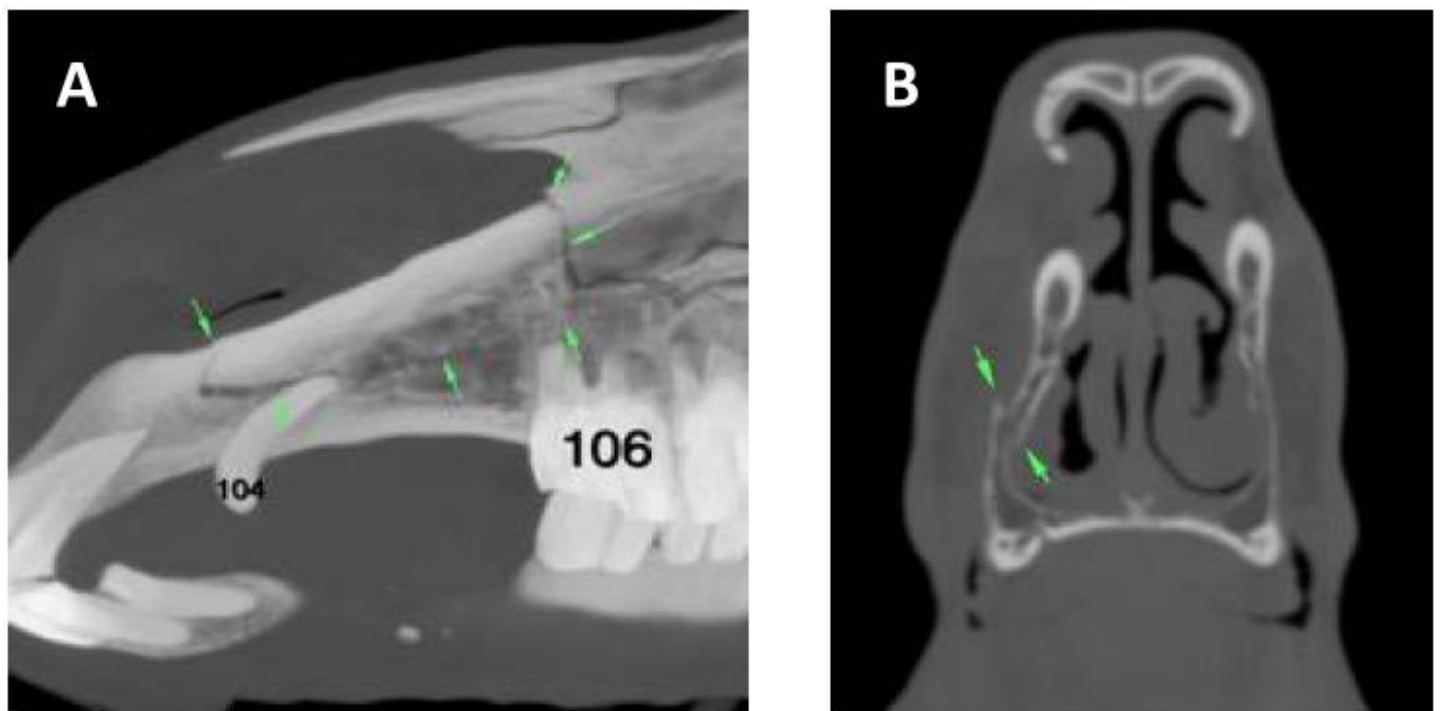
Figure 1. CT slices.

Radiography and digital tomosynthesis exams were performed for fractures diagnostics and precise localization. The follow-up CT exam (Fig. 1 and 4) completely confirmed previous digital tomosynthesis results (Fig. 2 and 3). The detailed report prepared by Dr. Vet. Joana Ramos presented in document “**CR1. Multiple Skull Fractures. Joana Ramos. Version 2.pdf**”.

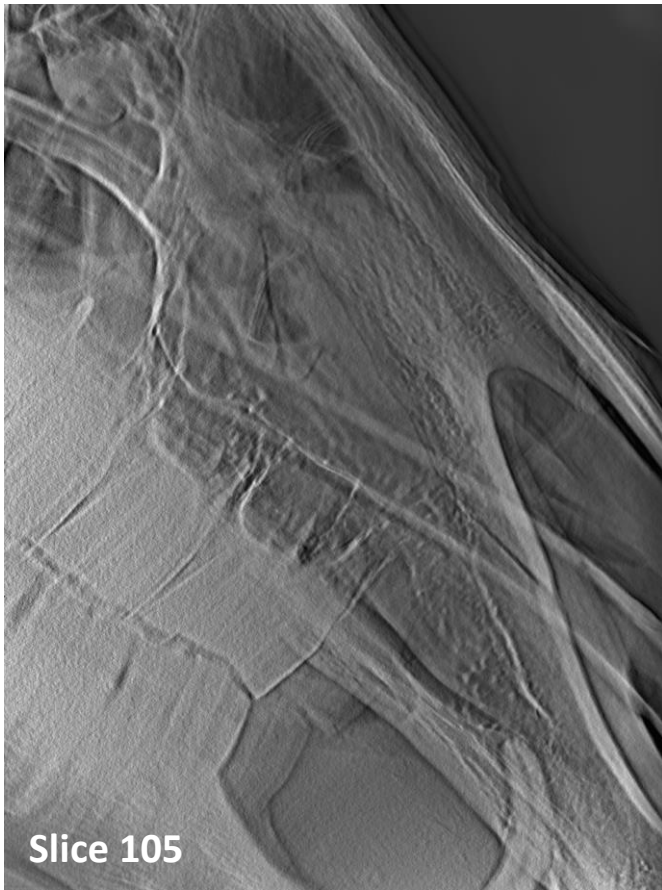
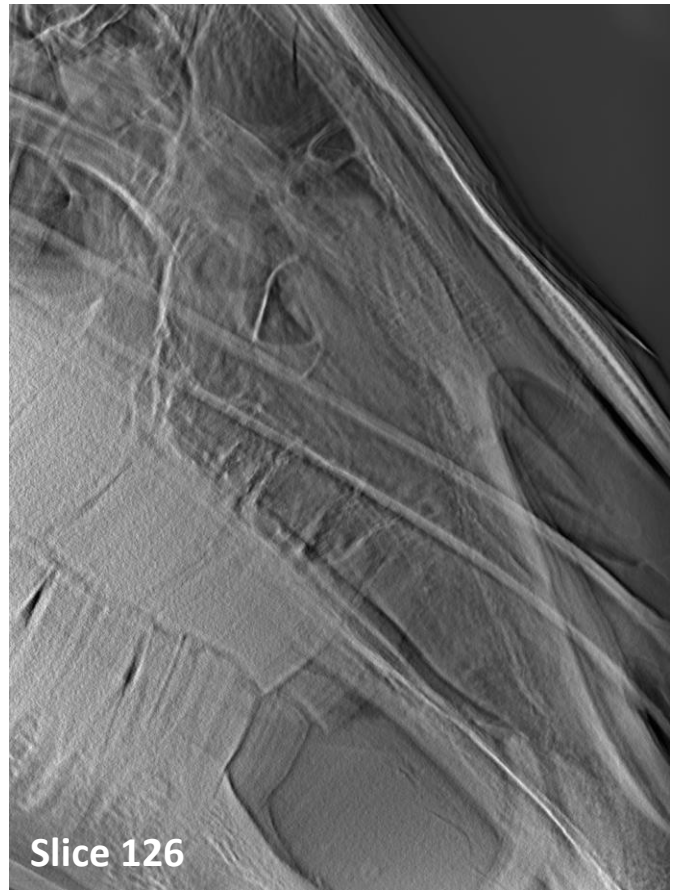
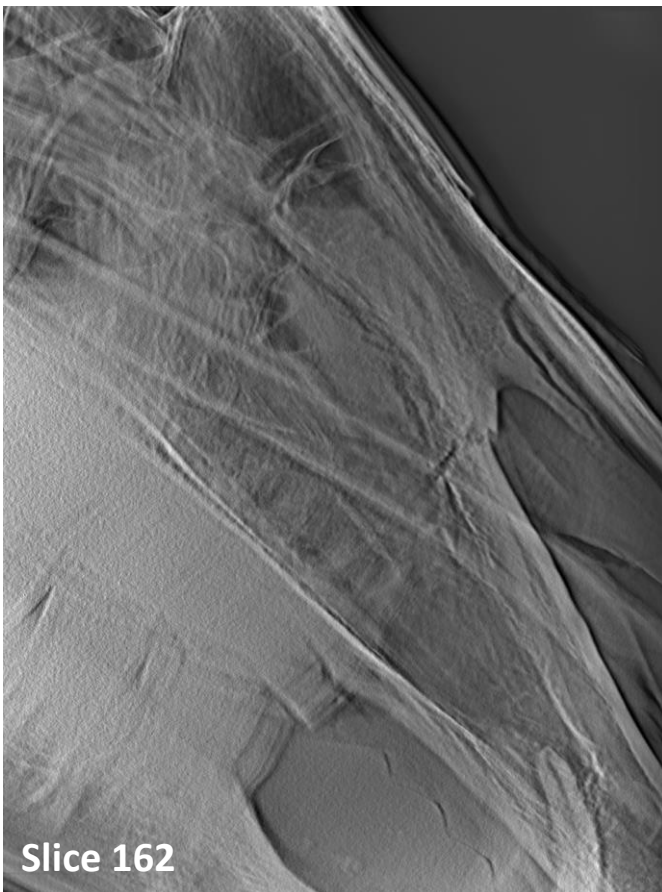
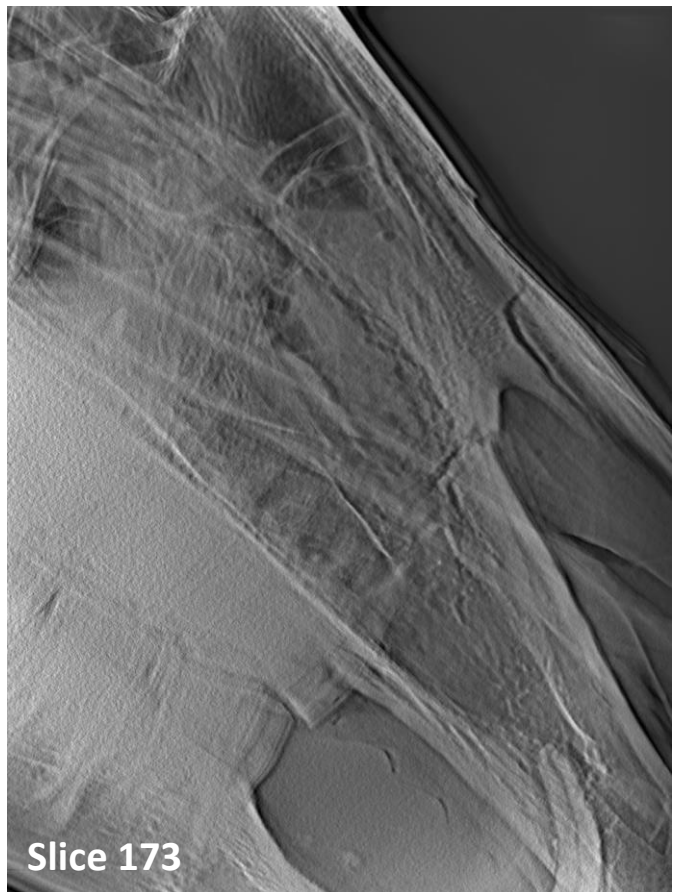
Figure 2. Tomosynthesis lateral view slices (L Head LM).

Digital tomosynthesis study demonstrated similar images diagnostic value comparing to the CT.

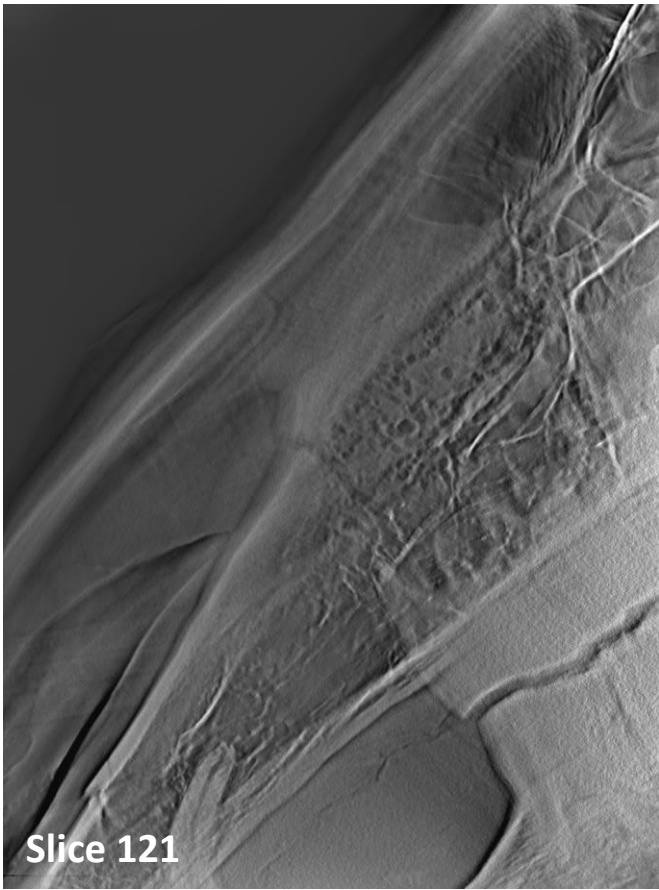
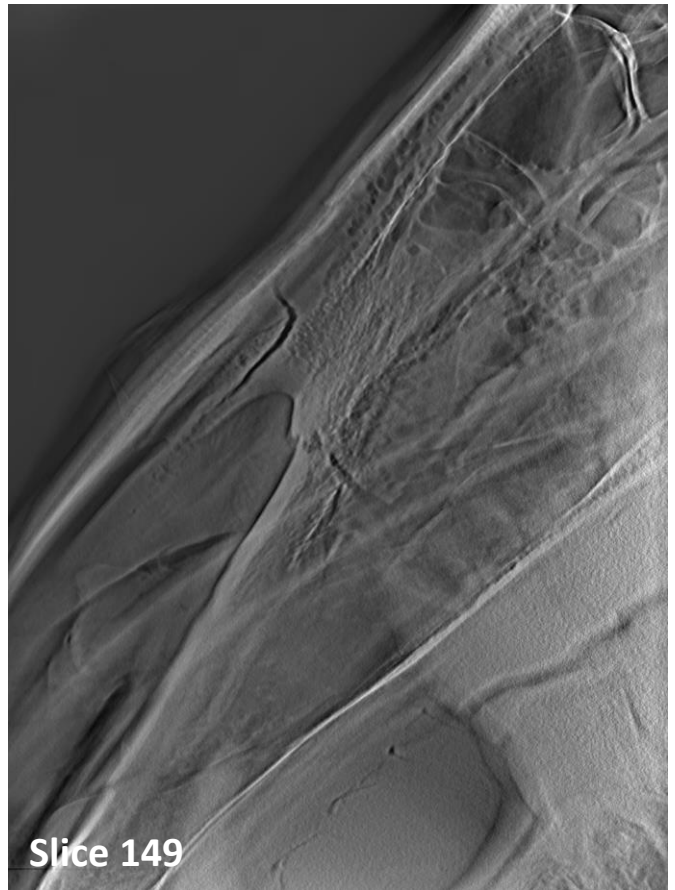
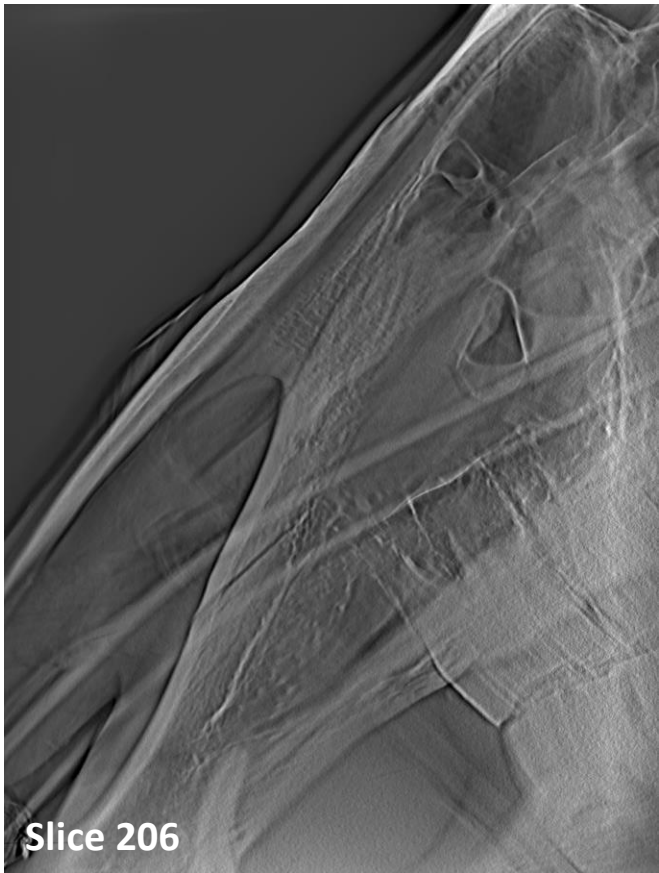
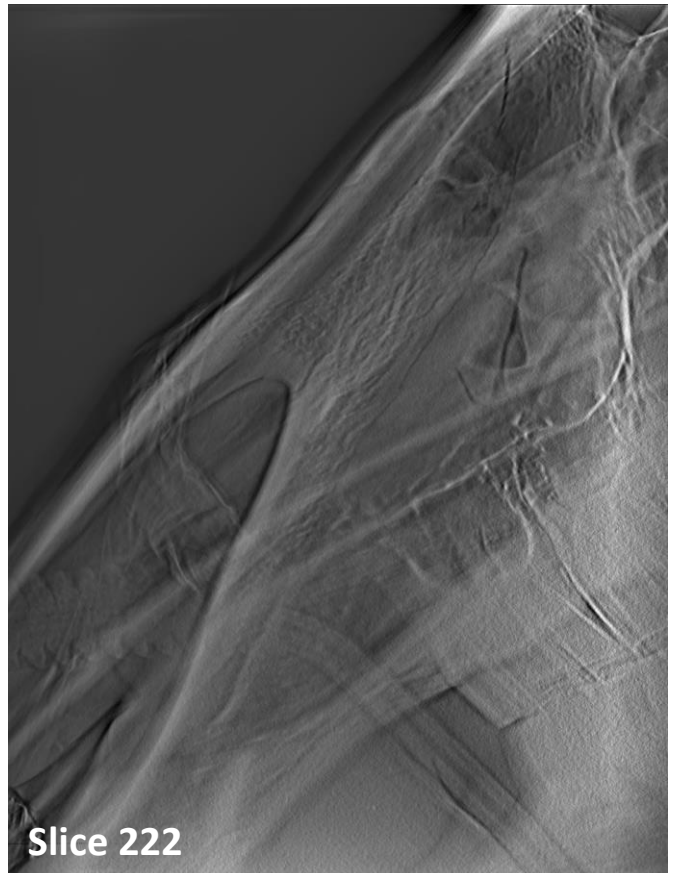
Figure 3. Tomosynthesis lateral view slices (R Head LM).

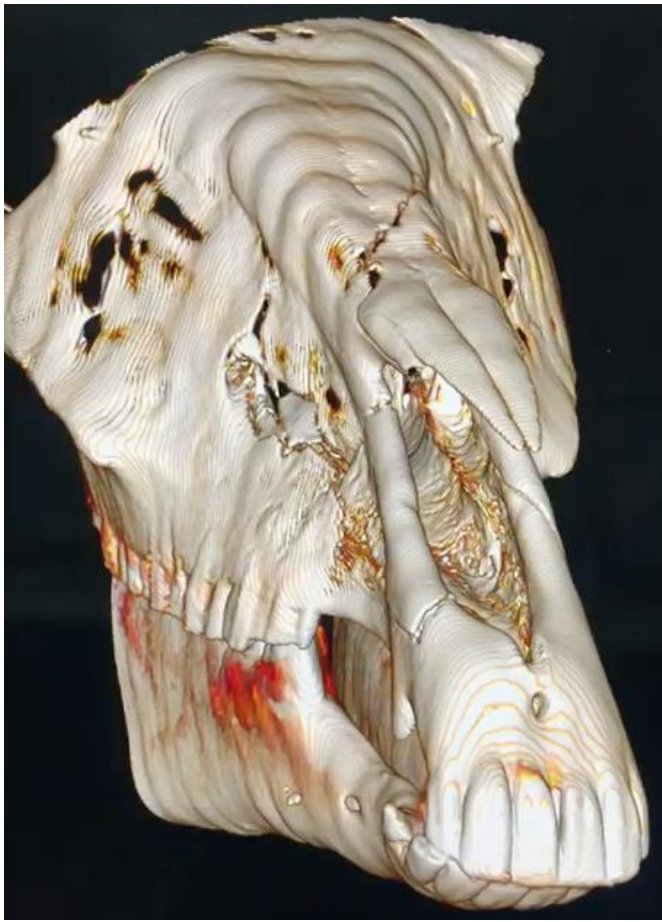
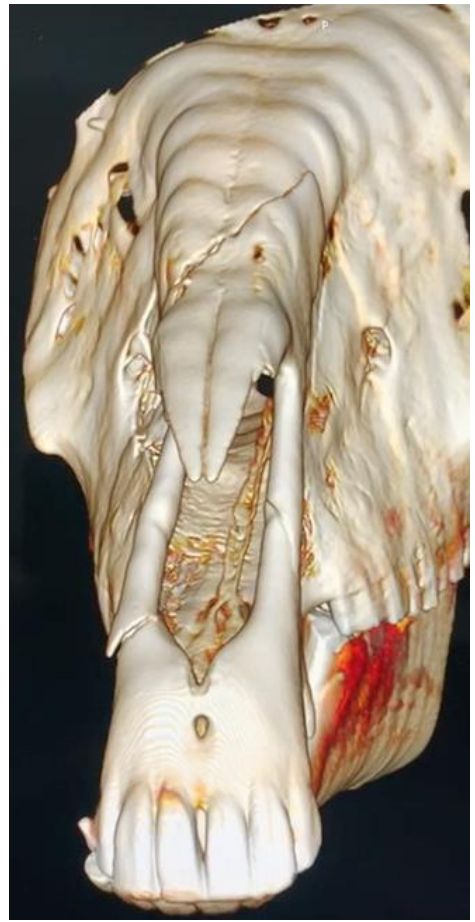
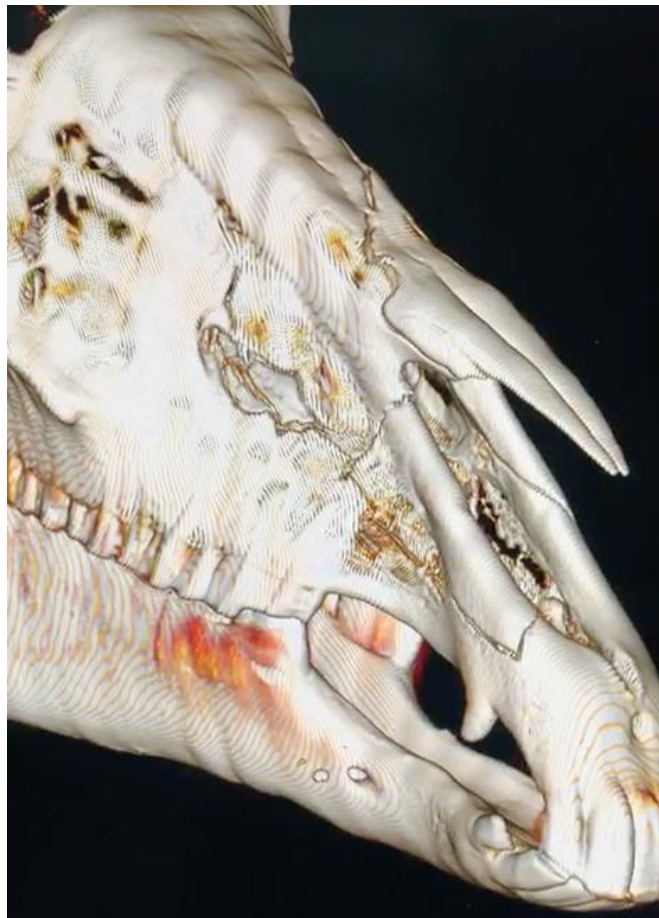
Figure 4. CT volume rendering.
