### Case "G" – fetlock.

Briefly, the results of the discussion RAD images, tomosynthesis (DTS) scans and MRI images of horse named G (RH Fetlock) were as follows:

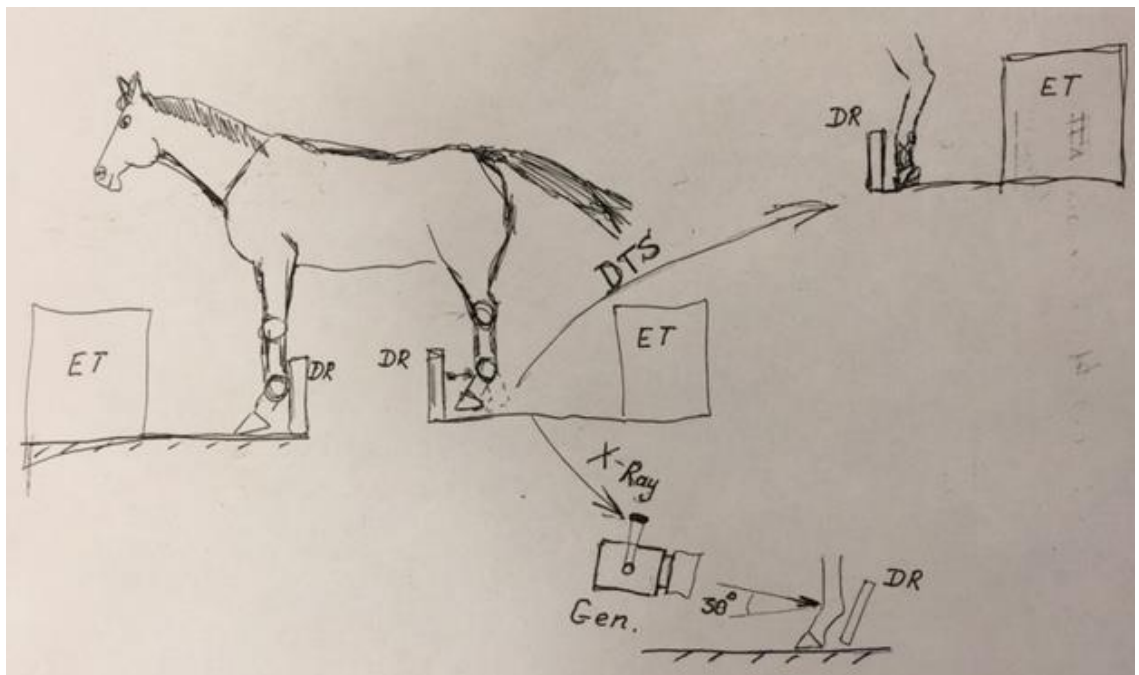
Fig. 1

1. Both RAD images and DTS scans acquired perfectly. We have some minor comments on the DP DTS scan. With the natural position of the horse's hind leg and the DP DTS scan (central position in Fig. 1), the X-rays inclination angle differs from the inclination angle that traditionally used in radiography (in Fig.1 at bottom right and your image in Fig.2). As a result, sesamoid bones are superimposed on third metacarpal bone (cannon bone) on DTS scans. The next time we offer to perform a DTS scan using a stand (in Fig.1 at top right). In this case, the angles of X-rays for radiography and DTS will be similar. In addition, for the DTS scan the distance between the joint and the DR will be decreased. The images of the joint will be more detailed.

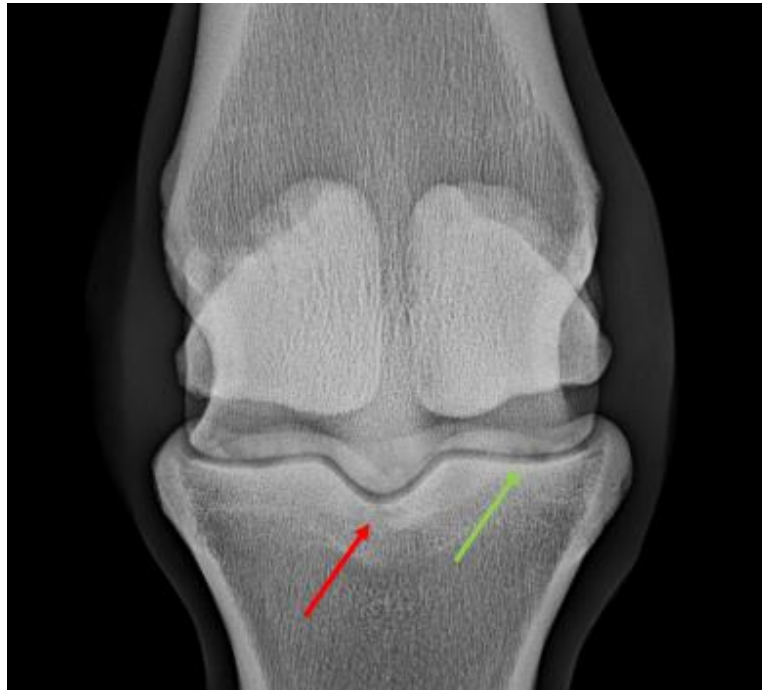
2. In the RAD image of Fig.2 FETLOCK AP RH "G", with a green arrow you showed a dark spot with a contrast  $K=0.12$ .

3. On the RAD image Fig. 2 FETLOCK AP RH "G" with red arrow you indicated a dark spot with contrast K=0.1. This formation is clearly visible on the MRI image Fig. 5, taken from your letter.

On RAD images we do not see degenerative formation of this form shape.

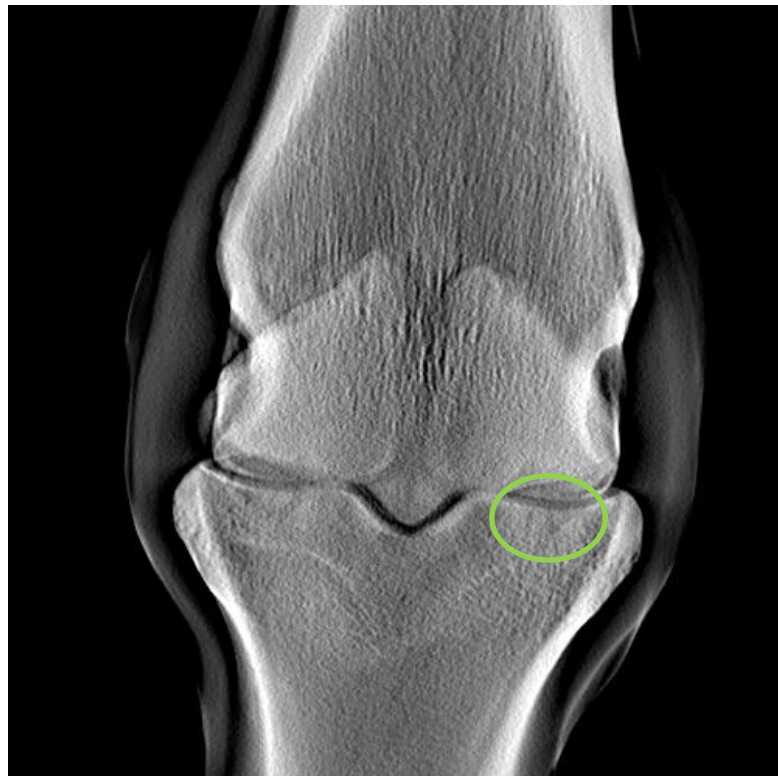
Fig. 3.

The possibility of DTS layers separation in depth allows you to observe separately sesamoid bones and other bones of the joint that are located closer to the DR.

On the DTS DP scan on layers -68...-85 (distance 10mm in depth), the corresponding two spots with the contrast  $K=0.15...0.17$  are visible (Fig. 3). Proximal phalanx bone on layers -68...-85 is visible out of focus (in focus on layer -24). Maybe these two spots belong to the sesamoid bone. The MRI confirmation is required.

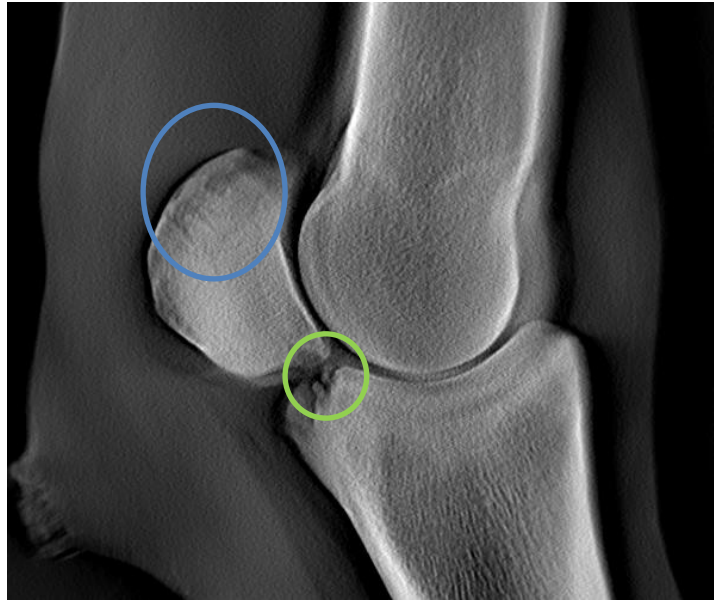
Fig.4

The sesamoid bones themselves have degenerative changes. Lateral sesamoid bone has more significant changes. This is clearly seen (circled in blue) on the LM slice -60 (Fig.4). Changes are visible on the slices -45...-75, which corresponds to 18mm depth. Proximal phalanx bone changes (circled in green) are additionally visible on the -60 slice (Fig.4).

Proximal phalanx bone changes – possible, two osteophyte fragments – are additionally visible on the slice -60 (Fig.4).

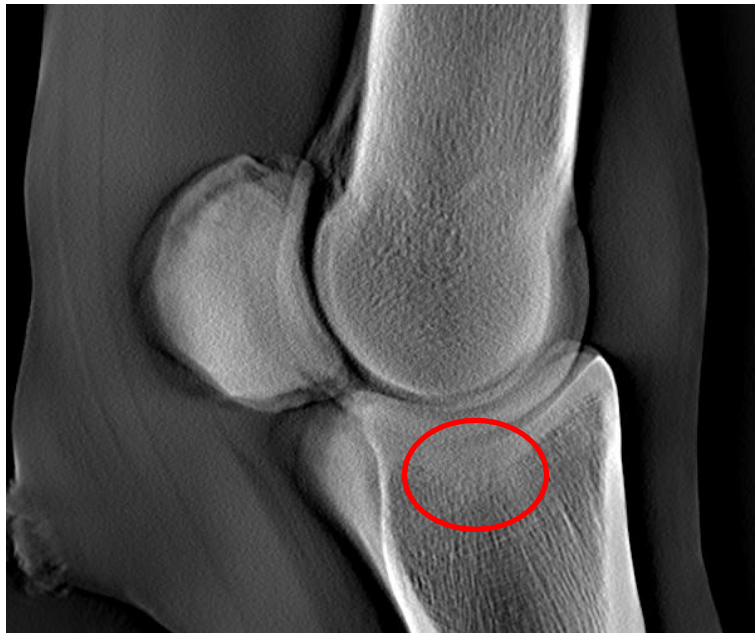
Fig. 6

A similarly shaped zone with a degenerative structure is visible on the DTS LM slice -90 (Fig.6).

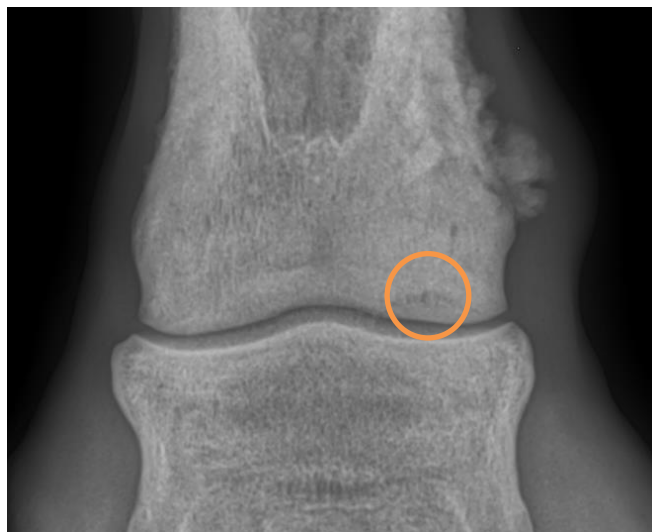
Fig. 7.

5. In the Kiev equine clinic we performed examination of horse named "AB". RAD DP image of LF Foot shown on Fig.7.

Slice on Fig. 8 shows the proximal phalanx bone structure. The deviation contrast measurements on slice 22 (circled in rose color) give the values on the left  $K_D = 0.13$  and on the right  $K_D = 0.06$ . Thus, you can register a 50% reduction in X-ray density of the bone beam structures. On the RAD image on Fig. 7 such measurements are incorrect, as it is not obvious which bone area in depth they are related to.
