1. Case "Bxxxxx" – carpal joint.

1.1. Extreme changes in left carpal joint with two fractures.

2. Case "Bxxxxx" – carpal joint.

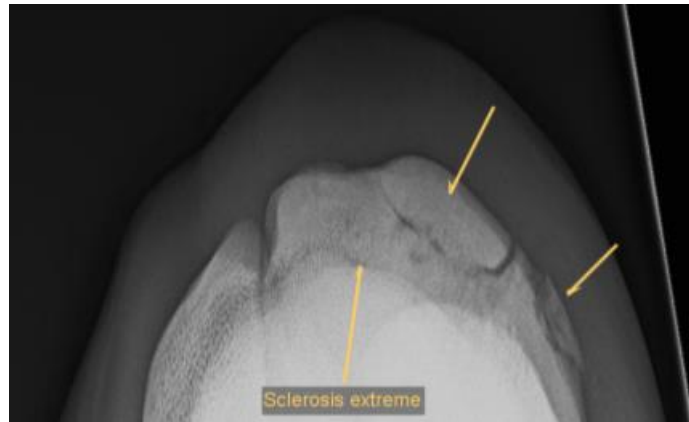
Fig. 1. RAD image Skyline view

The picture clearly shows two fractures (shown by arrows). According to our measurements, the contrast of cracks on the image at Fig. 1 is $K=0.45$, which makes it possible to visually separate the fragments from the main bone. On the original images on pages 1...4 two fragments are not visible at the same time. The contrast of cracks is $K=0.1...0.25$, which is close to the limit value of visual observation $K=0.05$ (Weber-Fechner law). Cracks are observable badly with possible errors. The worst image is shown on original page 1 (Fig. 2), where the fragments are almost invisible.

In the images of layers 45...80, three fragments of bone are well distinguished, and not one, as on the Fig. 1. The total size of the fragments in depth is about 20 mm, which is confirmed by the Fig. 1 and cannot be measured from the Fig. 2.

On layers 75...110, the left fragment in the image at Fig. 1 is visible. The size of the fragment in depth is about 20 mm, which is confirmed by the Fig. 1 and cannot be measured from the image at Fig. 2. Instead of one crack in the image at Fig. 1, tomosynthesis on layer 100 allows you to simultaneously see 3 cracks in the bone (Fig. 5).

Image at Fig. 1 differs from the rest of the RAD images (pages 1...4) in that it was possible to observe bone fragments against the background of soft tissues. This possibility is not always available. In contrast, a

1.2. Suspected sclerosis (Fig1, Skyline view).

"It is important to recognize that if the skyline view of the third carpal bone is not sufficiently dorsally protruded, either caused by inadequate flexion or inappropriate beam angle, the third carpal bone can look artefactual sclerotic and the corticomeddullary distinction cannot be adequately assessed."

Perhaps, because no sclerosis is observed on the tomosynthesis layers, we are dealing with the case of the *false positive* diagnosis, and there is no sclerosis on the bone!

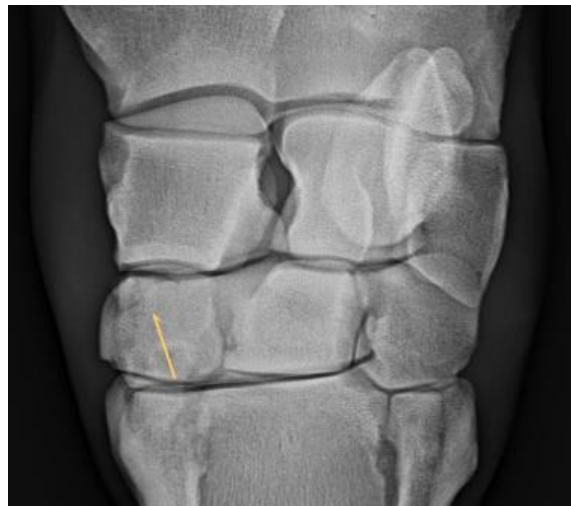
Fig. 2. RAD image DP view (original page 1)

To compare the capabilities of radiography and tomosynthesis, we took a scan you made in the direction of the worst image at Fig. 2. Layers 100, 65 and 61 of this scan are presented on page 8-9 (Fig. 3).

The measured contrast of main cracks in images of tomosynthesis scans at Fig. 3 is $K=0.7...0.85$, which is twice higher than in the best RAD image at Fig. 1 and 3...8 times more than the original RAD images (pages 1...4). The contrast of other cracks in tomosynthesis is about 0.3, in the RAD image at Fig. 2 these cracks are not visible. Such an increase in contrast was previously shown by us on phantoms and makes the diagnosis more reasonable.

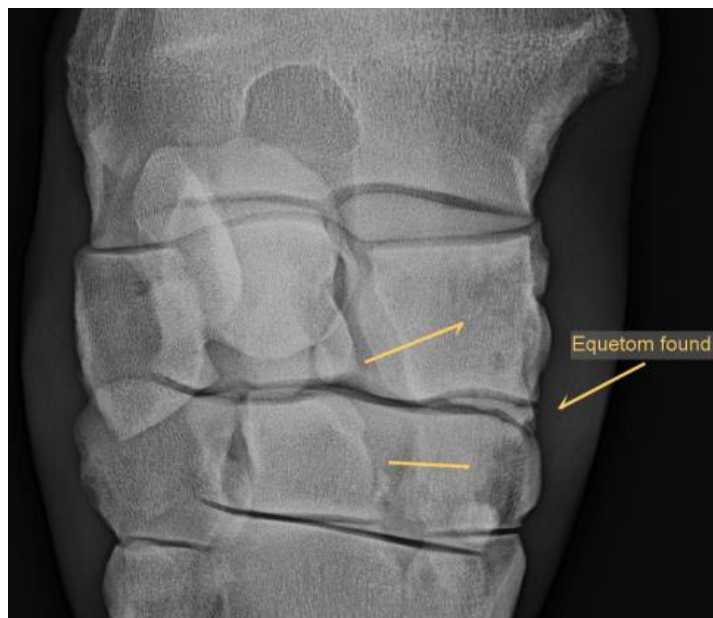
On RAD images at pages 10, 11 the pathological zones marked by arrows (Fig. 6, 7).

Fig. 6. RAD image DP view (original page 10)

2.1. Top arrow in RAD image at Fig. 6 indicates a suspicious area with a superimposed heterogeneous structure on the image of the bone. To clarify the situation, an additional RAD image at Fig. 7 was acquired, where it is possible to observe the non-uniform formation of 3 fragments against the background of soft tissues. Fragments in the picture Fig. 7 have contrast $K=0.5...0.55$.

2.2. Lower arrow on RAD image at Fig. 6 indicates a low brightness area. The reason for the reduced brightness may be in the reduced bone density and in the artifact appearance from the heterogeneity of the bone thickness. Closer to the edge, the total thickness of the bone decreases, and an x-ray image at the edges forms a zone with reduced brightness in the negative image, which follows the projection of the dense cortical part of the bone.

The depth of the low density area is about 24 mm. Thus, tomosynthesis confirmed a decrease in bone density in the zone shown by the lower arrow in the image at Fig. 6. The magnitude of the decrease in bone density is much less than it may seem from the image at Fig. 6. According to our measurements on the tomosynthesis layers, the decrease in bone x-ray density is 8...10%.

In the image at Fig. 6 these irregularities are poorly visible. It is interesting to know your opinion about the anatomical cause of these heterogeneities.

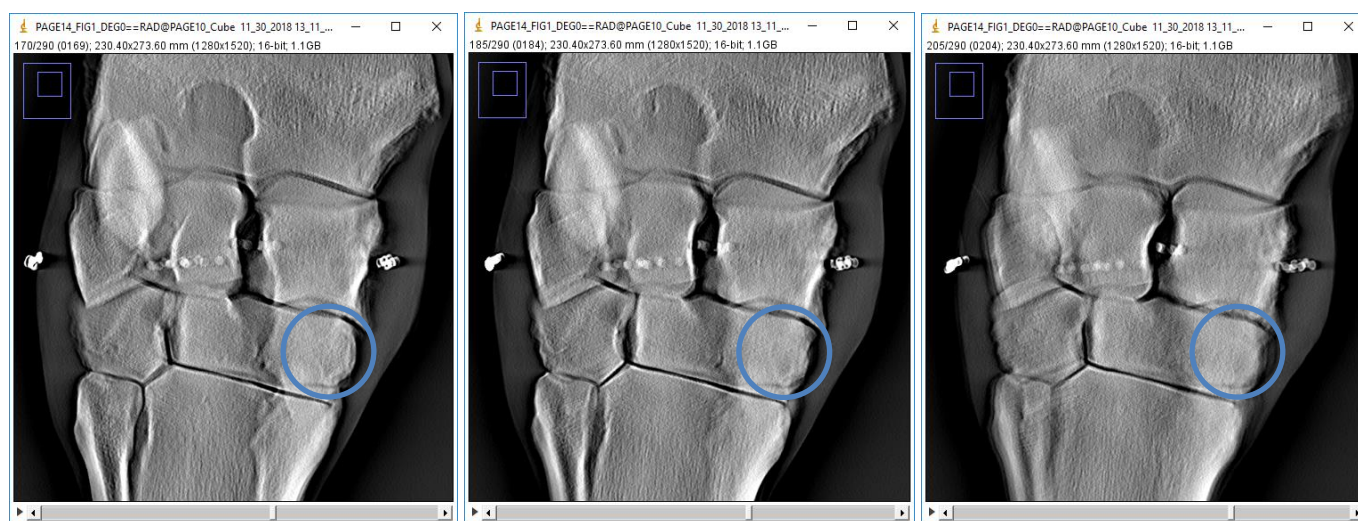
To check the reasons for the decrease in brightness, it is convenient to use the additional information acquired by tomosynthesis. On the tomosynthesis scan #2, made in the same projection as the RAD image at Fig. 6, the left outer border of the third carpal bone is clearly visible, causing the artifact to appear in the image at Fig. 6. At the same time, a reduced density is also visible on layers 170...210 of the tomosynthesis scan #2 (Fig. 10).

Fig. 10. Slices 170...210
