# EQUINE TOMOSYNTHESIS

Splint (F0035, 20 Apr 2020)

**Short description:** Splint bone fracture.

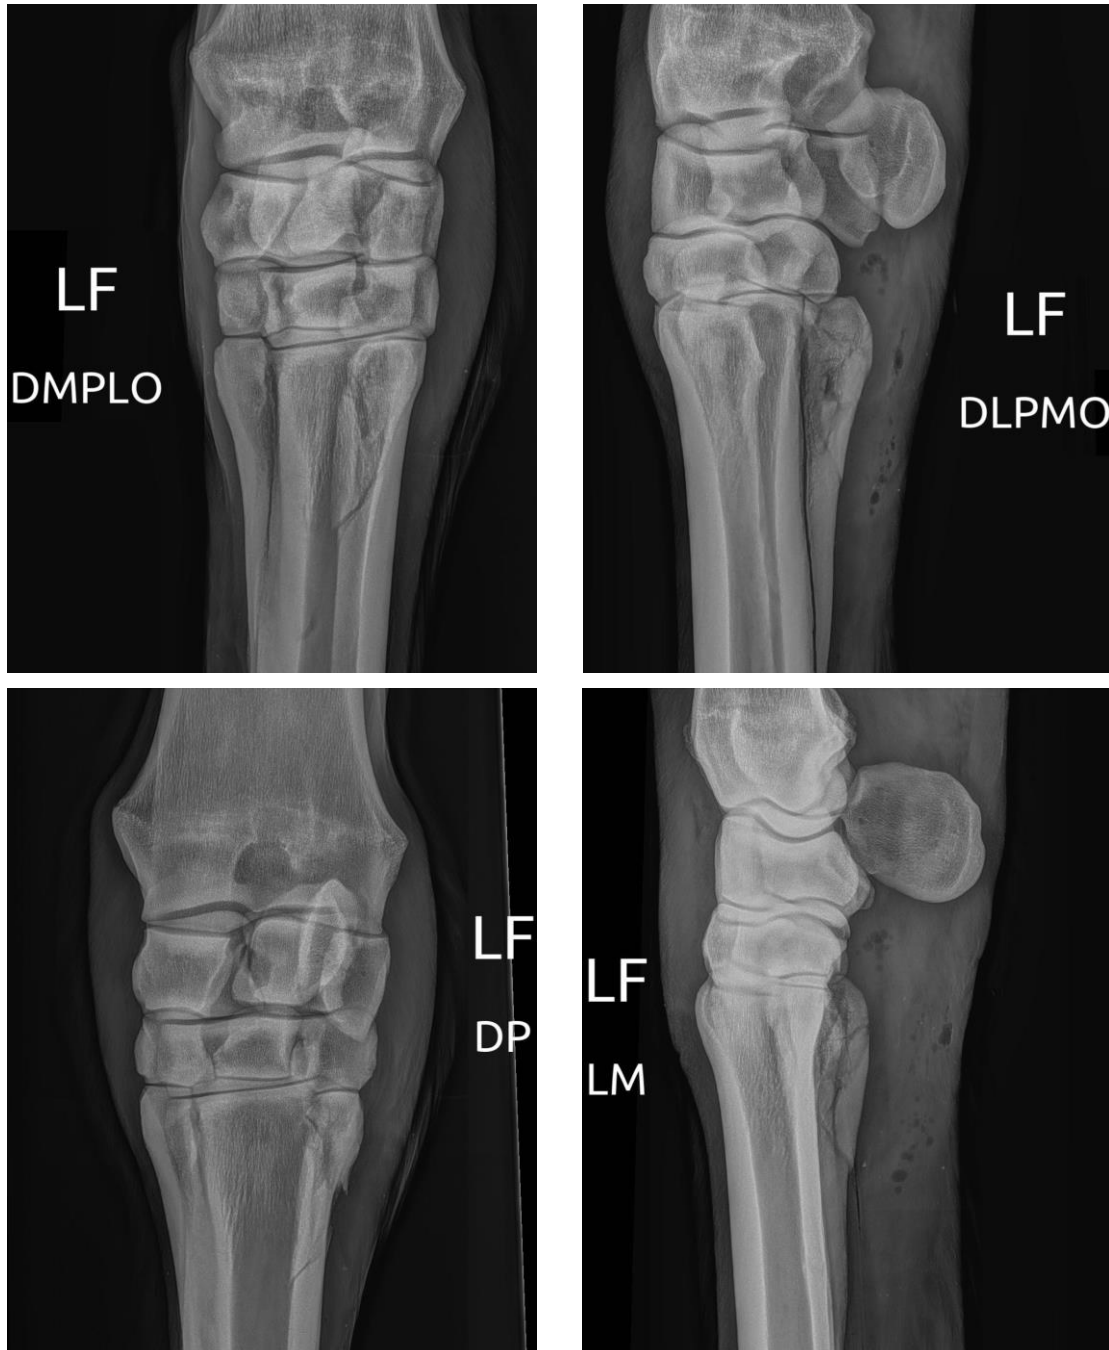
Seventeenth years old icelandic horse, found severe lame in the left front with a wound lateral at the cannon bone. Therapy with antibiotics and the then horse was referred to the clinic after x-ray the next day (Fig 1).

**Diagnosis:** Open comminuted fracture of the lateral splint bone.

Fig 1. X-ray images of fracture (07 Apr 2020).

Surgical treatment of the wound was done to reduce risk of bone infection of the fracture.

Conservative treatment of the fracture itself in a full-limb cast for 2 weeks and a normal cast after that. The horse was put into the swing-lifter for the first days (but horse didn't accept it).

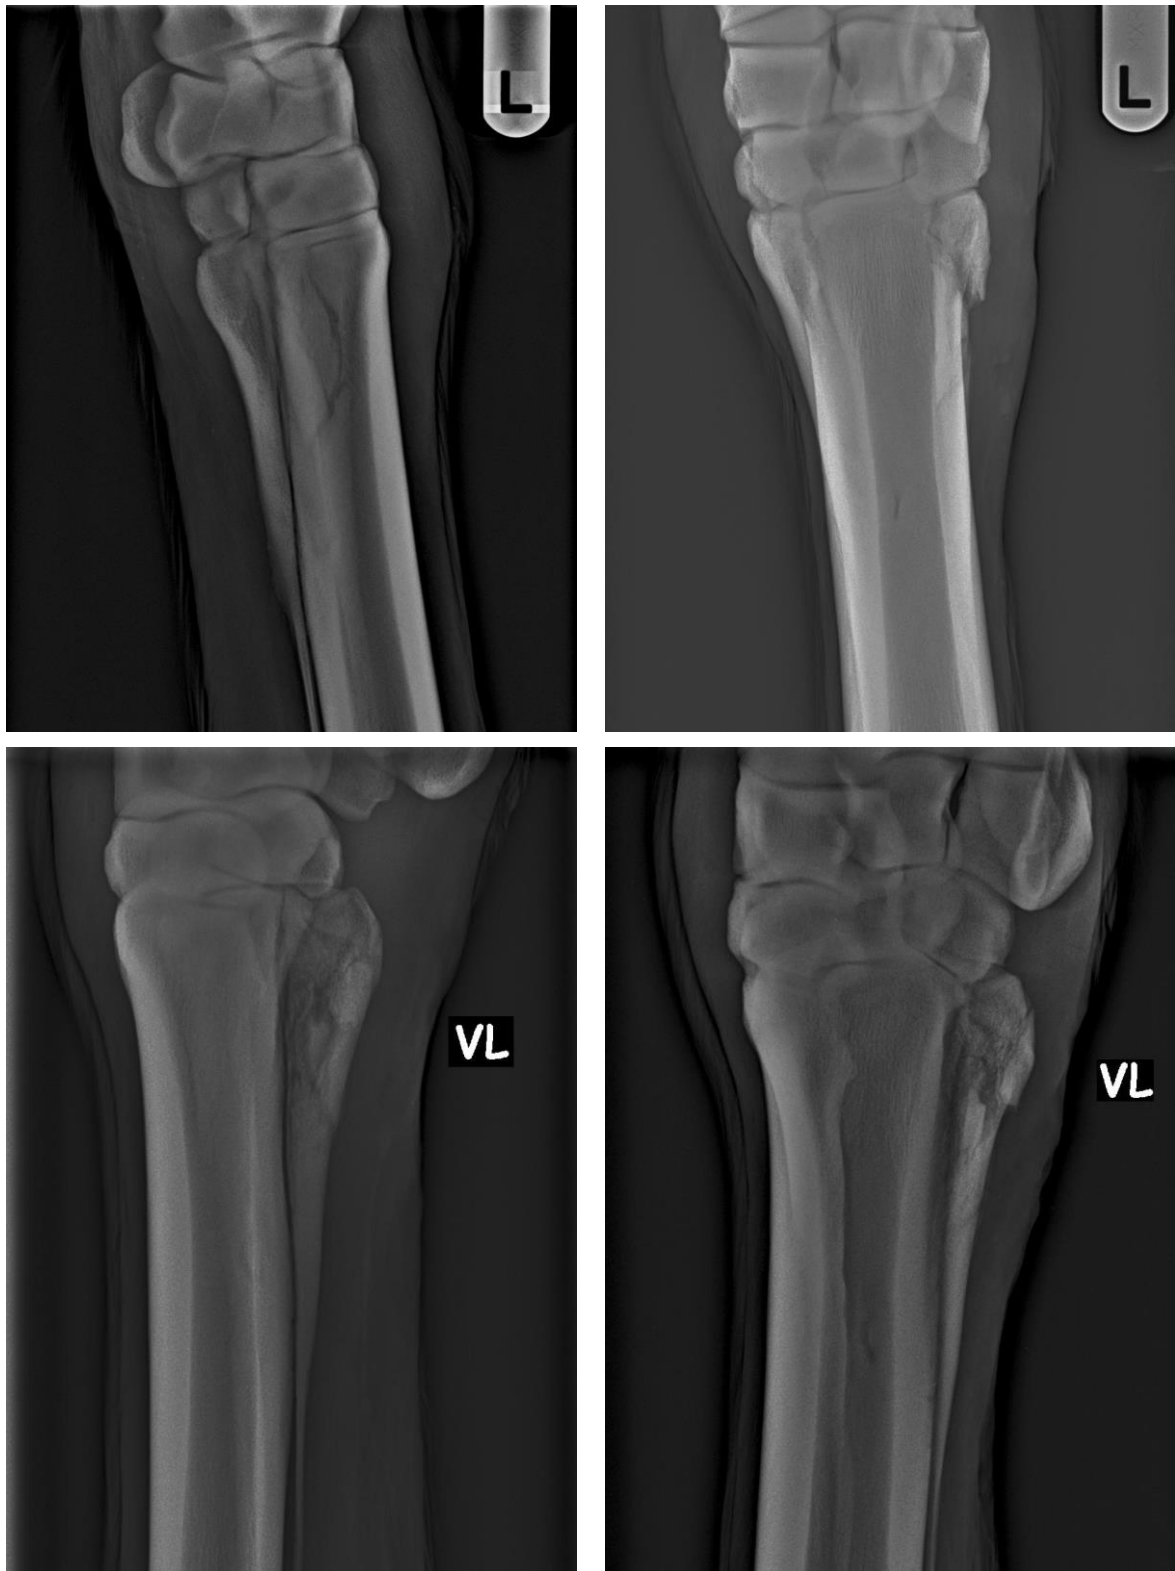
Fig 2. X-ray images of fracture (20 Apr 2020).

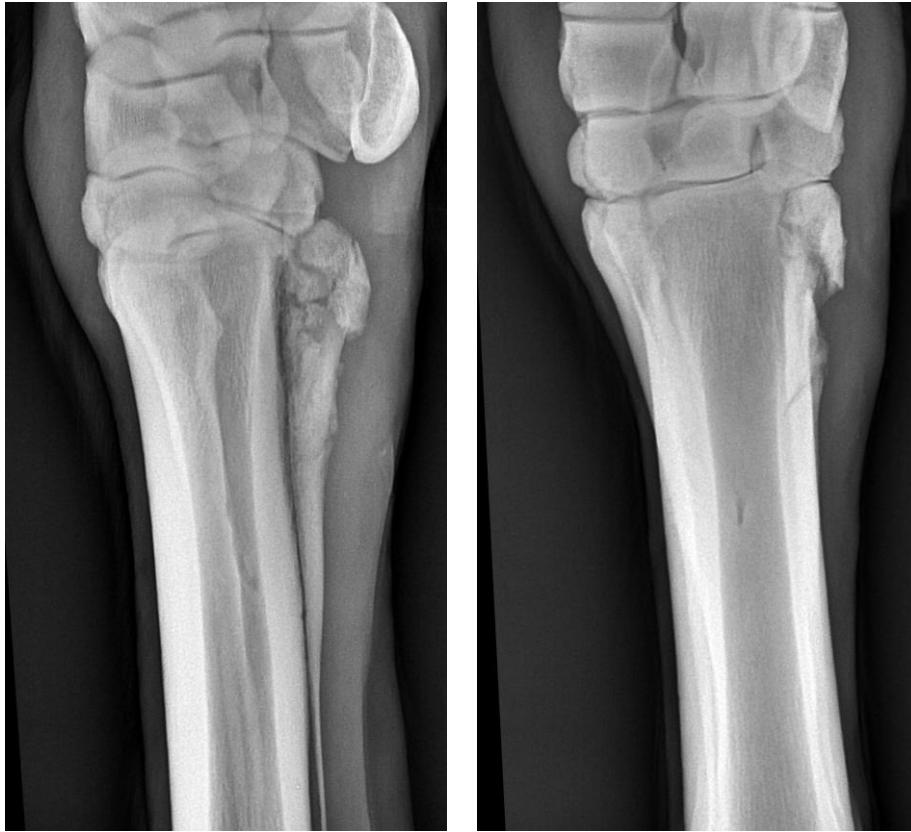
Fig 3. X-ray images of fracture (11 May 2020).

Horse went home when weight bearing in cast was good with mild lameness in walk. Follow-up x-rays almost 1 month after initial injury were performed and sent by referring vet. Euthanasia was recommended as osteosynthesis was not good option as the carpal joint was progressing instable with a high risk of carpal joint arthrosis.

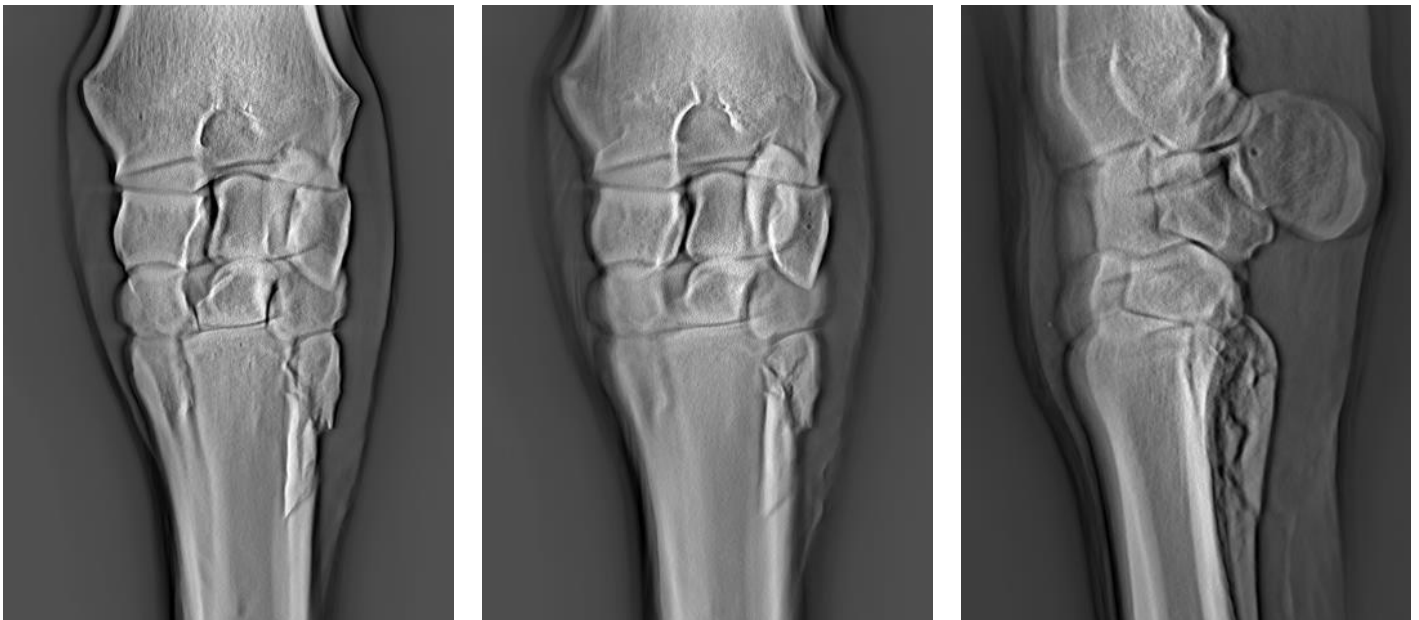
After 2 weeks an EQUETOM examination was performed and brought additional information about the situation of the carpal joint.

Fig 4. Tomosynthesis DP (#94, #78) and LM (#98) views slices of fracture (20 Apr 2020).

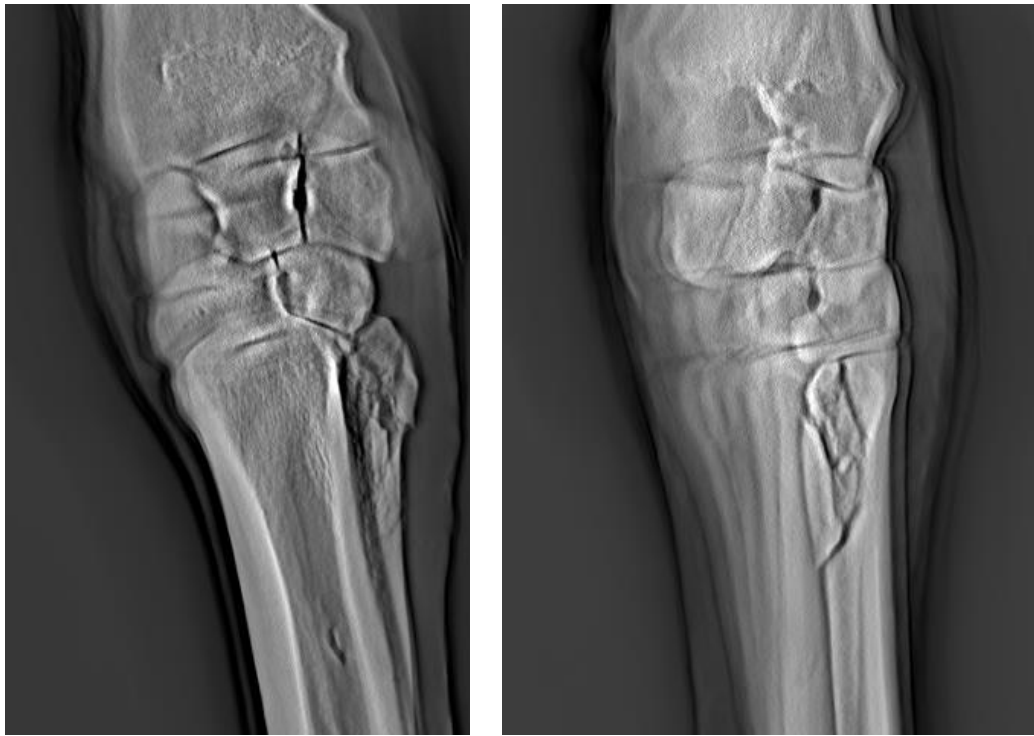
Fig 5. Tomosynthesis DLPMO (#109) and DMPLO (#82) views slices of fracture (20 Apr 2020).
