EQUINE TOMOSYNTHESIS

Foot (B0024, 18 Dec 2019)

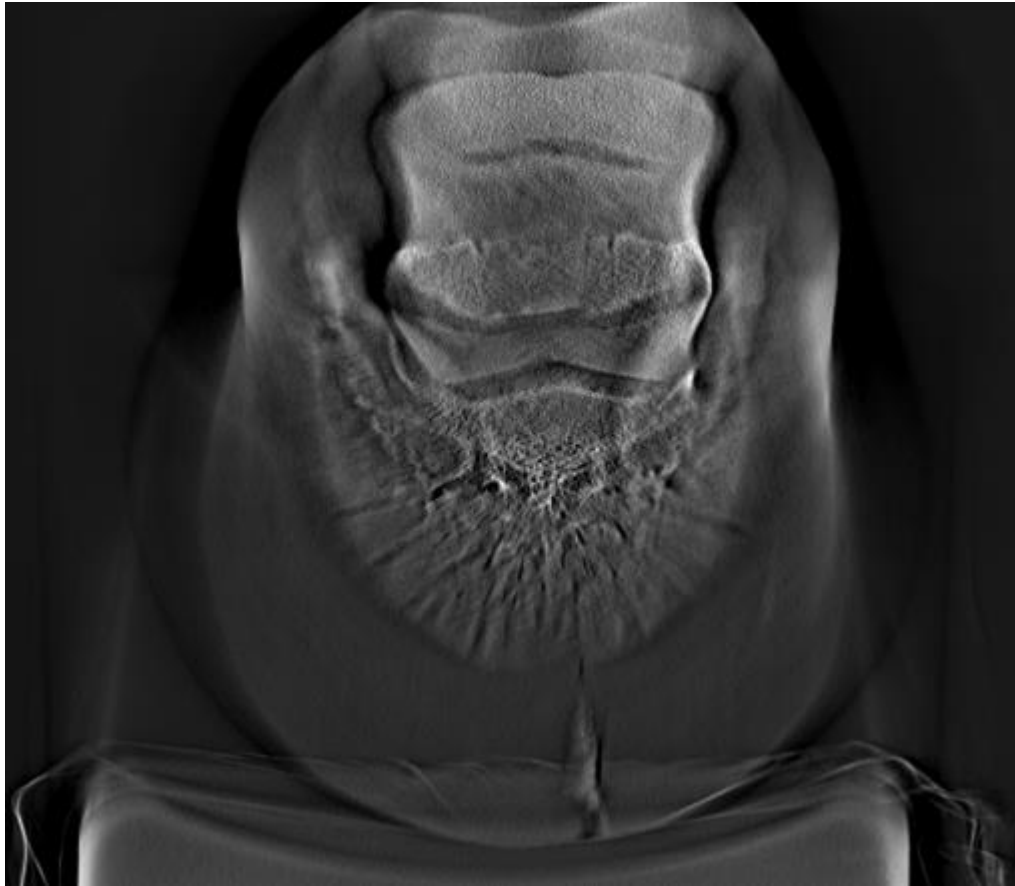
In the right front hoof, there is a contrast line of the front wall of the hoof capsule from the hook, in the direction to the corolla.

Diagnosis: Crack of the hoof wall.
