EQUINE TOMOSYNTHESIS

Pastern (C0036, 10 May 2020)

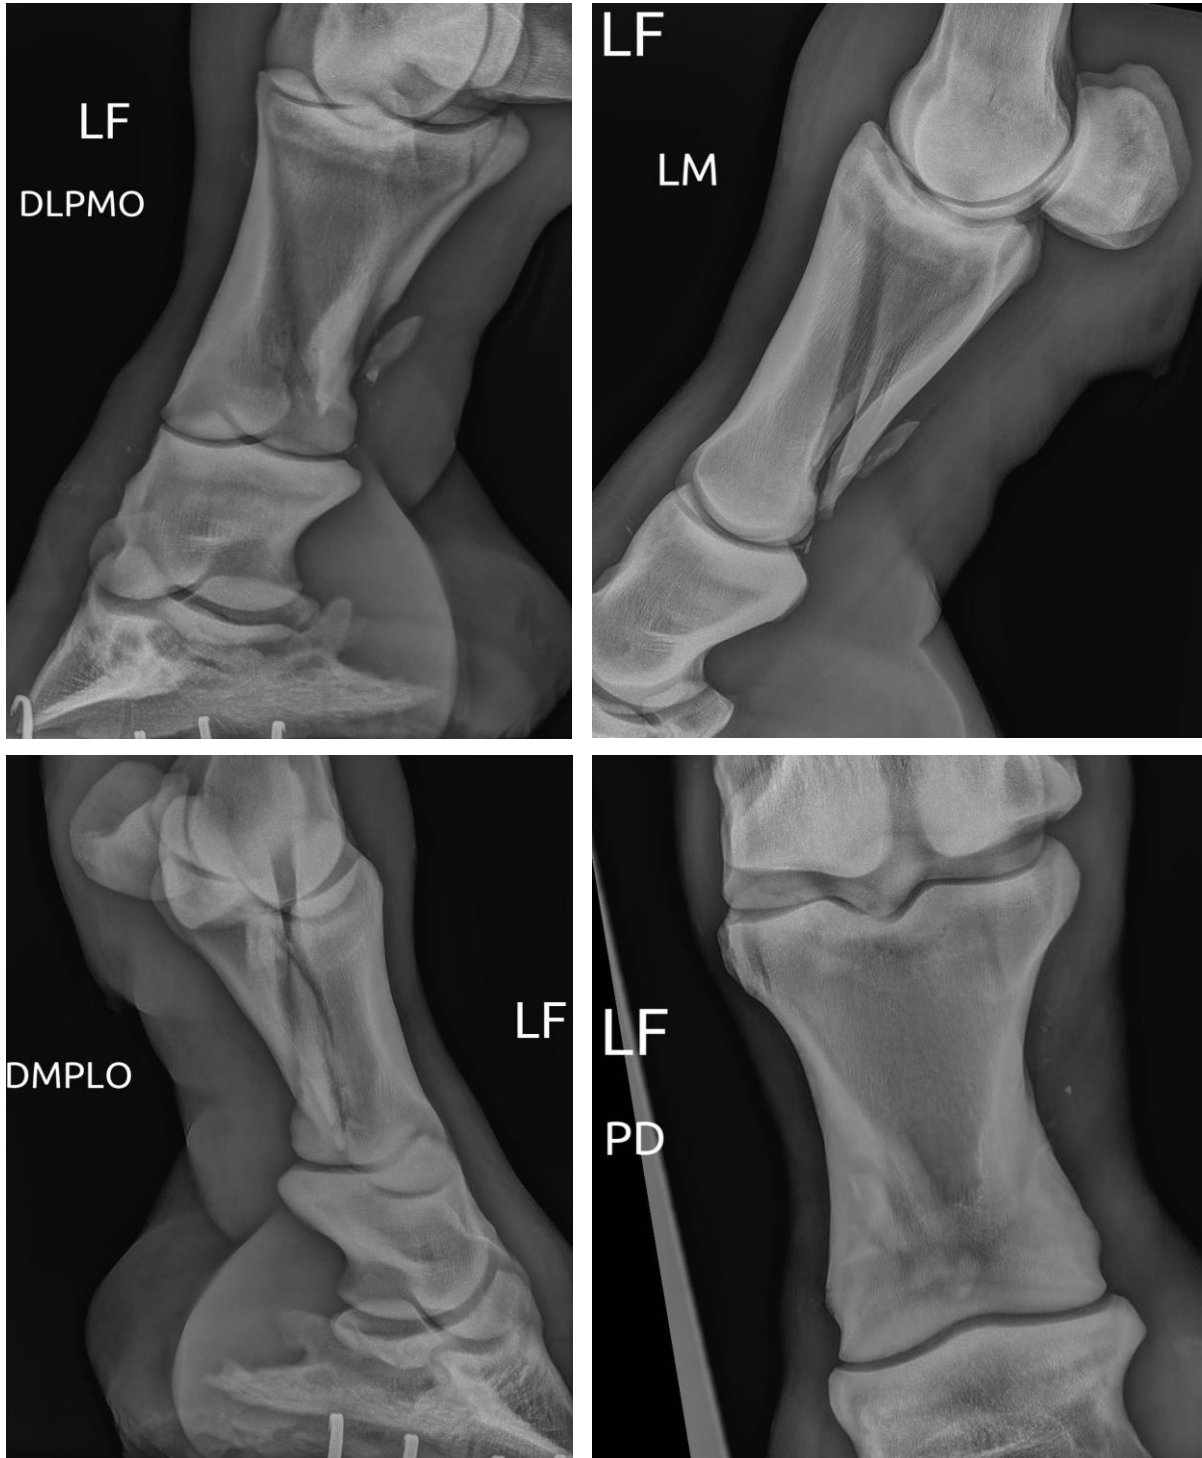
Fig 1. X-ray images of P1 fracture.

Ten years warmblood gelding (very tall horse!). Owners found horse on pasture severe lame left front. X-rays performed by referring vet at stable: helical fracture of P1 with suspicion multiple fracture lines. The limb was put into a cast and referred to clinic for surgery.

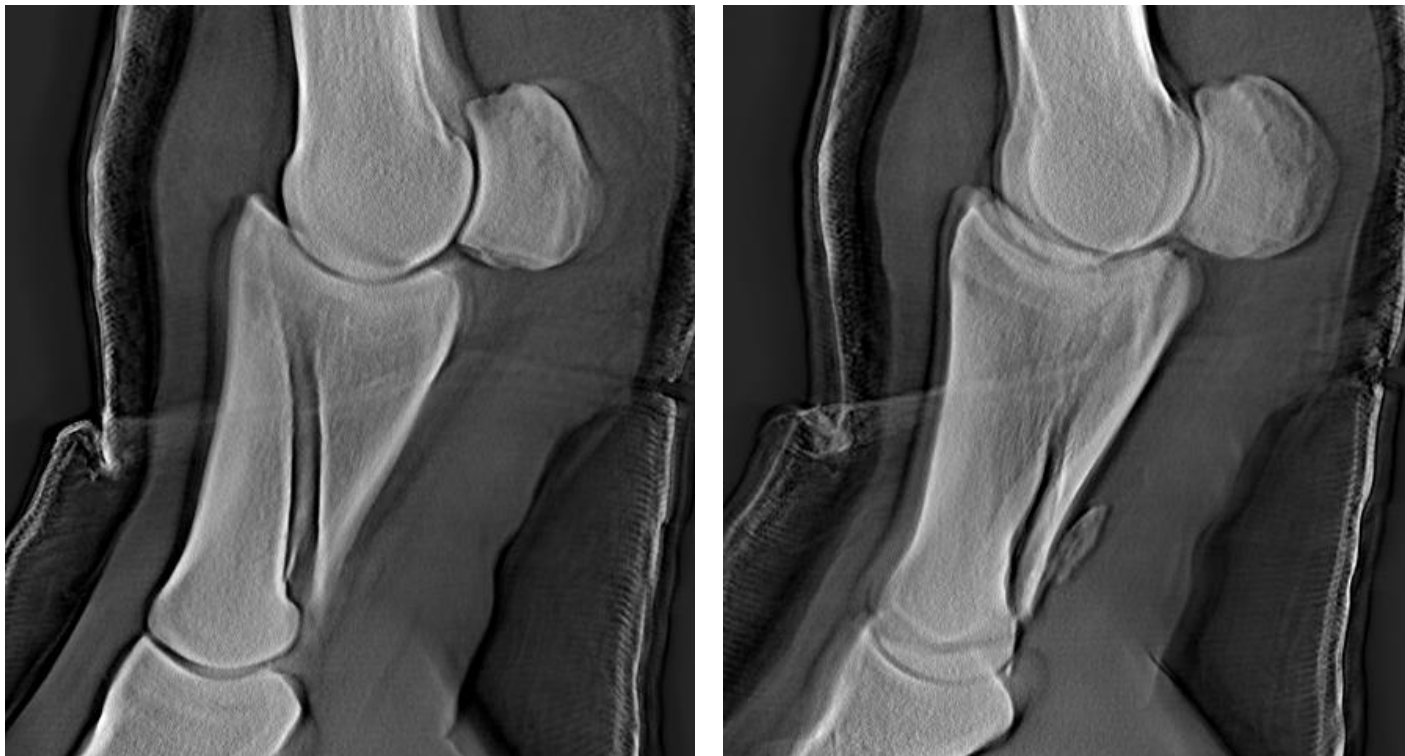
Fig 2. Tomosynthesis lateromedial view slices of P1 fracture.

For pre surgical planning an EQUETOM examination was performed (leg in cast that was already broken at the level of the fetlock joint). Several fracture lines with few bone fragments, an involvement of both joints (pastern & fetlock joint) and a luxated fetlock joint were detected.

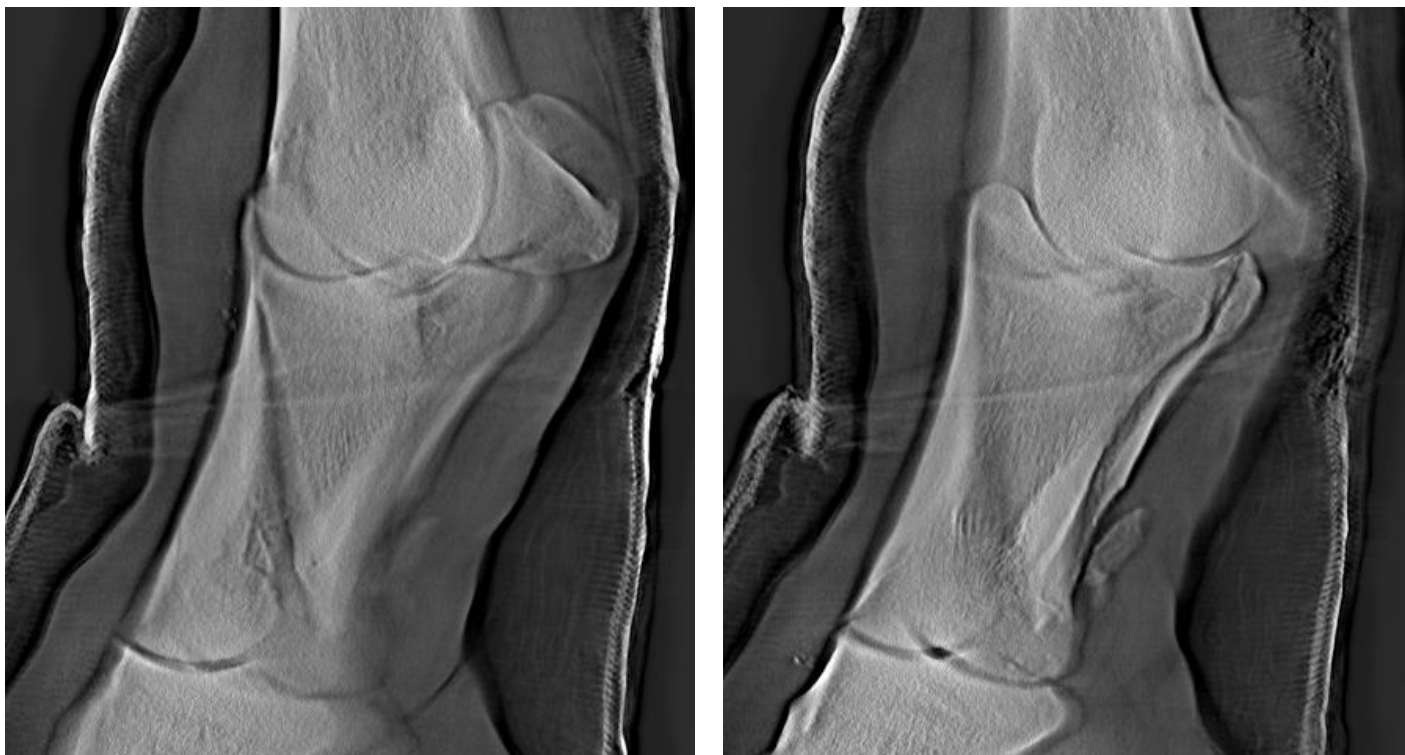
Fig 3. Tomosynthesis DLPMO view slices of P1 fracture.

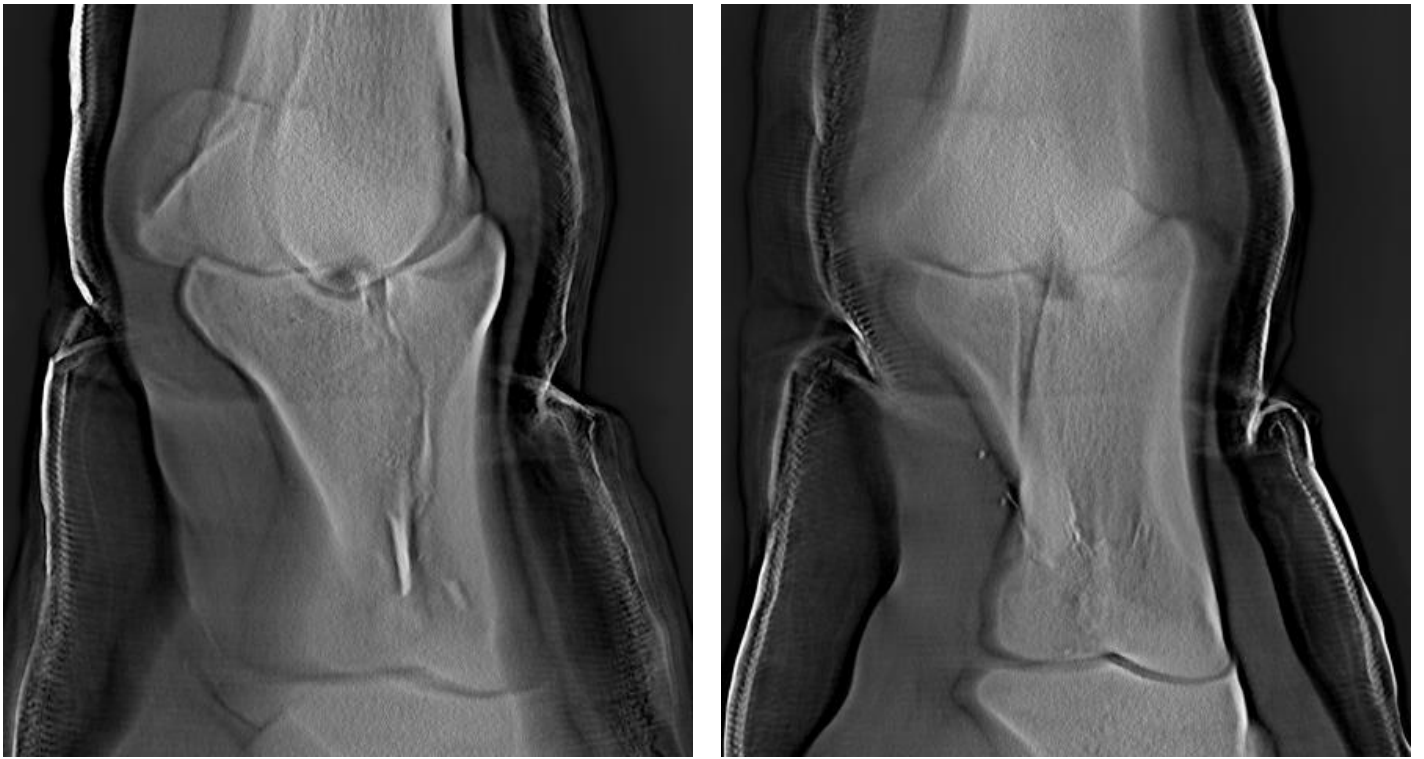
Fig 4. Tomosynthesis DMPLO view slices of P1 fracture.

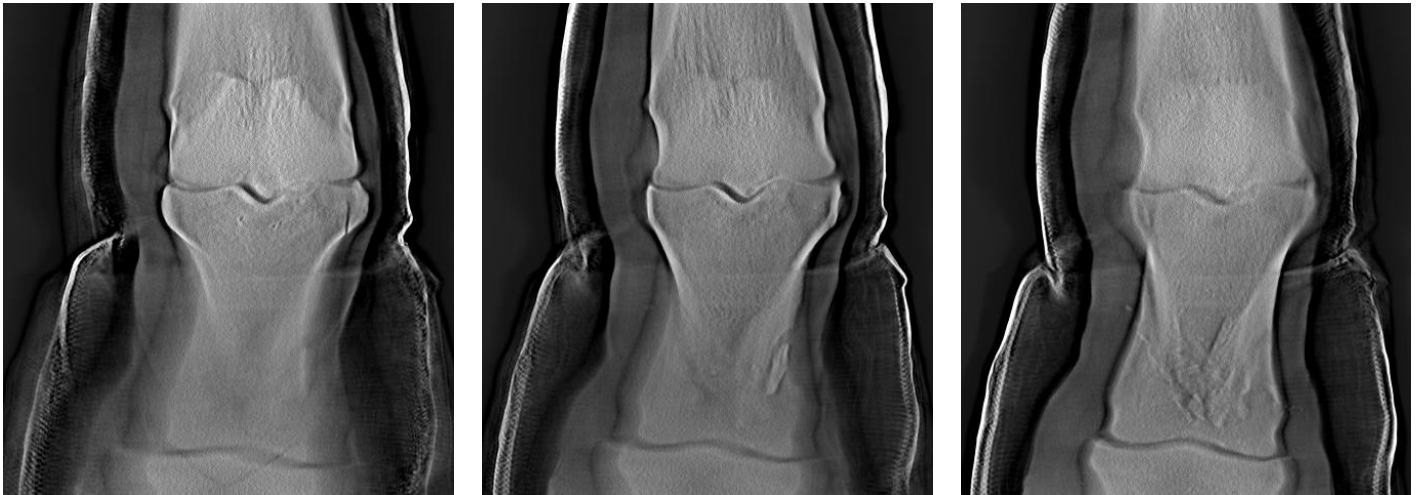
Fig 5. Tomosynthesis dorsopalmar view slices of P1 fracture.
